RE: One-Stop ADA Reviews

HURON JOB SERVICE

HURON JOB SERVICE PHOTOS

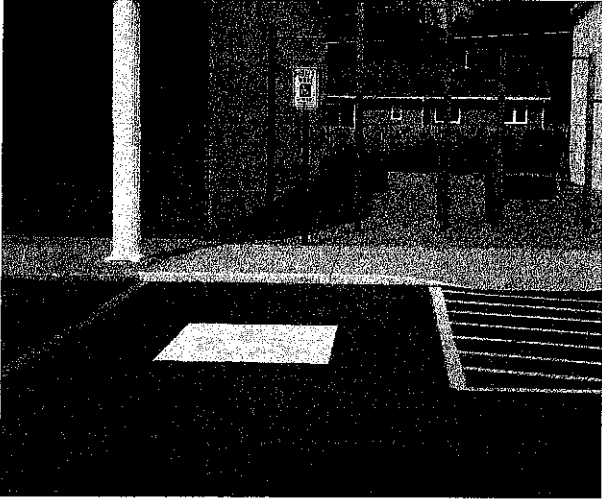
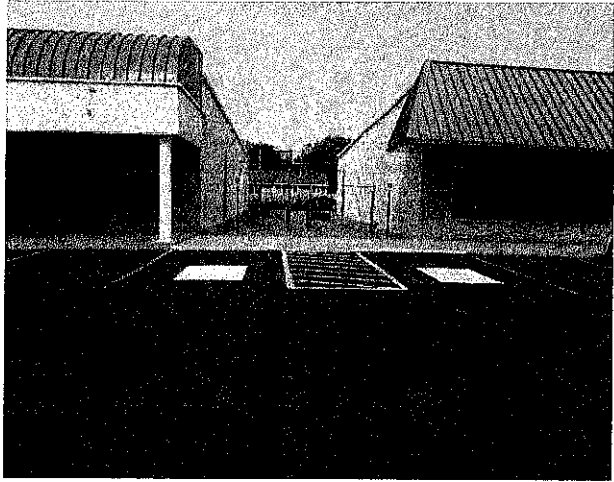
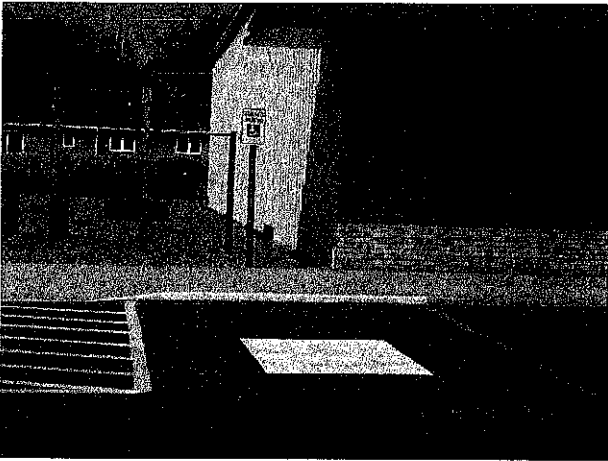
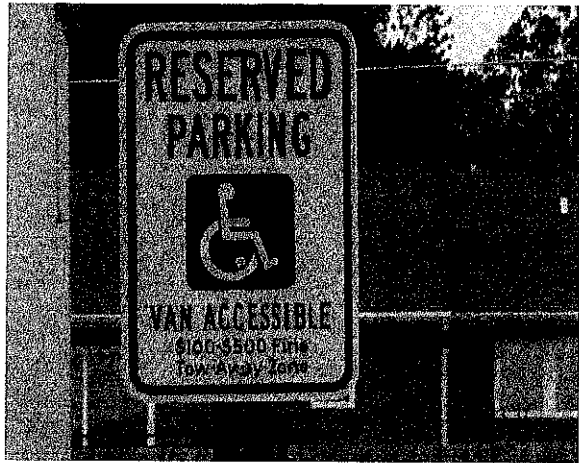
1. **Finding – Low Effort:** The main van accessible parking spot on the south edge of the parking lot is not identified with a ‘Van accessible’ handicap parking sign.

5. **Finding – Medium Effort:** The access aisle for the van accessible parking spot (south side of parking lot) is not designated or striped correctly.

Response: Resolved. The landlord removed the handicapped parking spot in front of the office and the one next to the north side of the building located to the south. They then created one parking space that is Van Accessible and the other that is Handicapped both located further to the north between our office and Anytime Fitness. And they created a handicapped parking space in front of Java Hut which is on this same campus, but it is located in front of the building to the south of us. So, they have the required three handicapped parking spaces with one of the three being van accessible. *Four pictures included.*

Response: Resolved. See the first finding. The handicapped parking spot in front of our office was completely removed as was the one on the north side of the building located to the south of us. And two handicapped parking spots, one of which is van accessible, were created further to the north of the building.

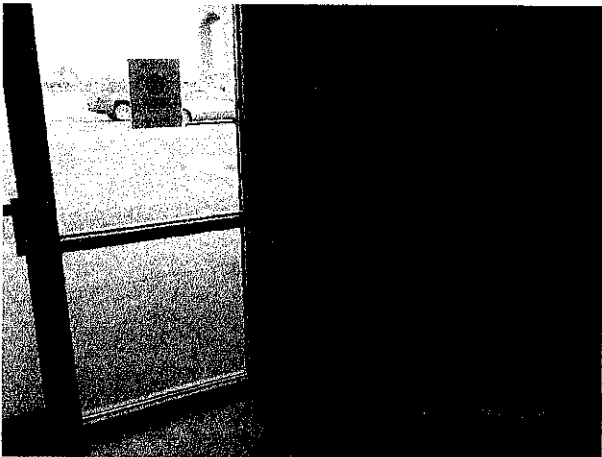
2. **Finding – Low Effort:** The lobby area light switch at the front of the lobby is blocked by chairs and a brochure display.
Response: Resolved. We have moved the brochure display to the other side of the door so as to not block the light switch. *One picture included.*
